#### ILLINOIS BOARD OF HIGHER EDUCATION

# **Crumbling Infrastructure at Public Universities**

February 2019

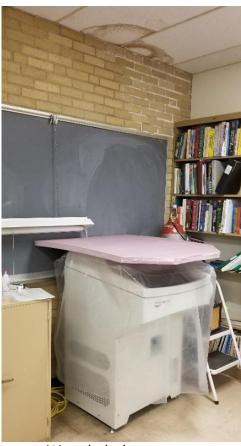
Water leak above cryostat (laboratory equipment)

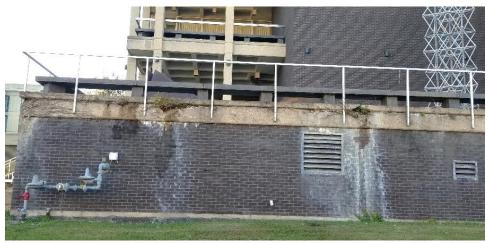
Water damage leading to structural failures

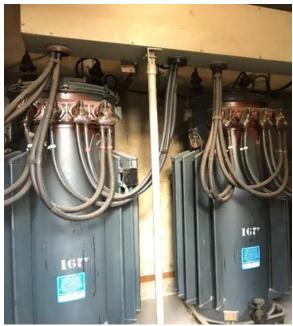
Transformer from the 1950s (with exposed live copper)

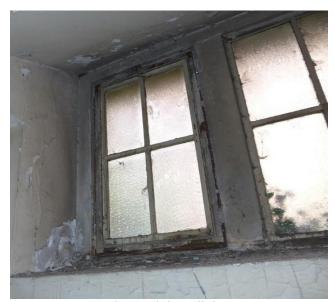
Window and drywall damage
